Report

Serious incidents on **18 March** and **8 April 2010**
at **Paris Charles de Gaulle Airport (95)**
to the **Boeing 747-400s**
registered **HS-TGL** and **B-HOV**
operated respectively by
Thai Airways International Ltd.
and by **Cathay Pacific Airways Ltd.**

BEA

Bureau d'Enquêtes et d'Analyses
pour la sécurité de l'aviation civile

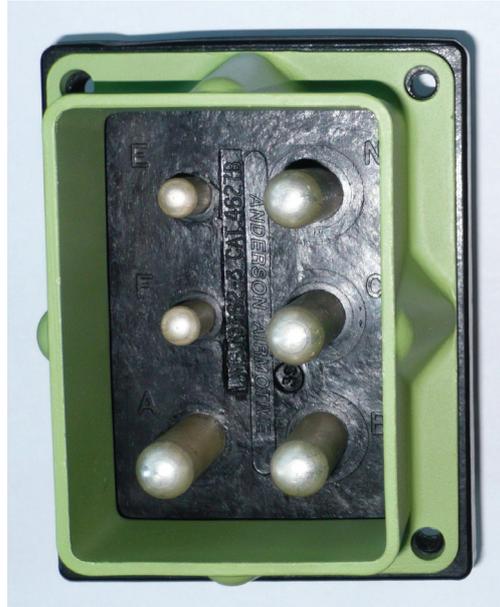
Following the first event reported to Boeing in 2001, an NTO was supplied to the operator concerned to install the guide from the B767 (Ref. MS.17845-1) in place of the part initially installed on the B747-400 (Ref. 66-9236). The replacement part ensures precise guidance. It is made of metal and is much more robust. It has been installed as a production part on the B747-400 since 2003.

According to Boeing, no cases of incorrect alignment have been reported to them on aeroplanes equipped with the MS17845-1 guide.
